## **Downed Power Line Claims the Life of One Volunteer Fire Fighter and Critically Injures Two Fellow Fire Fighters - Missouri**

### **SUMMARY**

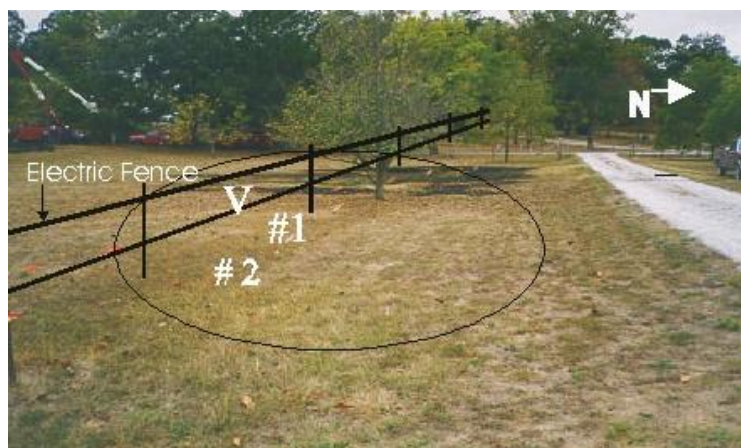
The Chief directed the driver to pull the Engine into a driveway on the north flank of the fire (Figure 1 below). Truck 3 (brush/wildland truck with a 250-gallon tank), with a fire fighter/driver, arrived at 0707 hours and was directed by the Chief to a position on the south flank of the fire. Immediately after Truck 3's arrival, two fire fighters (the victim and Injured #2) arrived in their POVs, pulled into the driveway on the north flank of the fire, and helped the driver of Engine 1 pull a 1-inch booster line. The driver of Engine 1 climbed on top of the apparatus and pulled the 150-foot booster line from the left side, crossing over the top of the apparatus and down over the right side. The driver fed the line to Injured #1, Injured #2, and the victim. Injured #1, Injured #2, and the victim crawled with the 1-inch booster line under the bottom wire of the electric fence (approximately 23 inches from the ground) into the field to attack the fire. Injured #2 grabbed the nozzle as Injured #1 and the victim served as back up.

**Figure 1.** Secondary Fire Site: Location of Victim (V) and Two Injured Fire Fighters (#1 and #2) in Relation to Electric Fence

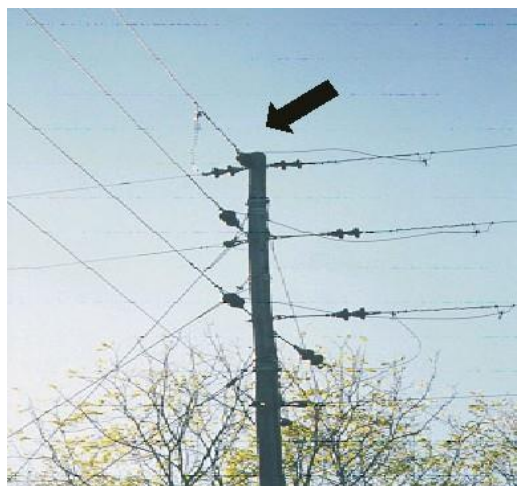
On October 4, 1999, at 0658 hours, a property owner notified Central Dispatch of a grass fire. The fire was started when one phase of a 3-phase, 7200-volt, overhead power line separated from the connection on a utility pole (Figure 2 below) and fell to the ground, igniting the surrounding grass area (Figure 1 below). When the power line fell, it crossed the road and a grassy field and came to rest on an electric fence, which it energized. At 0700 hours, Central Dispatch notified the fire department of a grass fire with a downed energized power line. At 0704 hours, the Chief was first to arrive on scene in his privately owned vehicle (POV) and parked approximately 20 feet from the end of the downed power line to alert arriving units of its location (Figure 3 below). The Chief conducted a scene size-up, and he reported a grass fire with a slow rate of spread and light fuel. He confirmed to the arriving units that a power line was down, and he indicated that the electric fence was energized due to the downed power line. (Note: This was an electric fence used to control livestock. However, the fence was not operable at this time.) He then radioed Central Dispatch and asked the power company to de-energize the line. Engine 1, which has a 1,000-gallon tank, arrived at 0706 hours with two fire fighters (the driver and Injured #1).

**Figure 2.** Point of Separation Between the Power Line and Connector

**Recommendation #2: *Fire departments should ensure that fire fighters stay away from downed power lines a distance equal to at least one span between poles until the power line is de-energized.***<sup>2</sup>

Discussion: As stated in *Fundamentals of Wildland Fire Fighting*, when downed power lines come in contact with the ground, current flows outward in all directions from the point of contact (ground gradient), and the energized area can extend several feet from the point of contact. Therefore, walking in proximity to the energized area could electrocute fire fighters. To avoid this hazard, fire fighters should keep ample distance away from the downed power line (equal to at least one span between poles) until the power line is de-energized. If the fire has not burned past the distance equal to one span between poles, fire departments should delay their attack until the fire has burned past this recommended span.

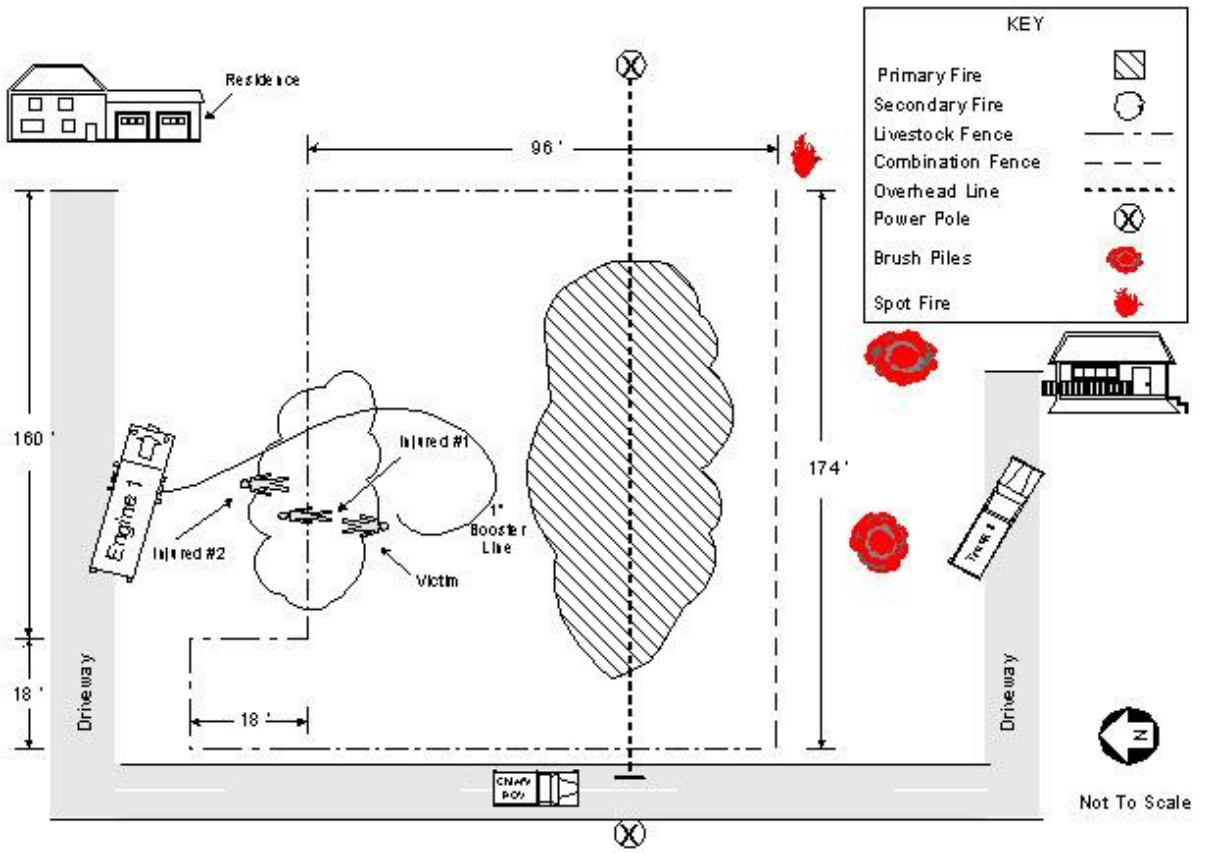
All three fire fighters were lying in the area of the secondary fire and their clothes were burning (see Figure 3 below). The Chief dragged Injured #1 out of the fire by the collar of her bunker coat. As the driver of Engine 1 pulled Injured #2 out of the fire, he began to pat his clothes, snuffing out the fire that was burning them. He then moved to the victim, pulled him from the secondary fire, and placed him a safe distance from the energized fence. The nozzle of the 1-inch booster line was approximately 10 feet from the fence inside the field. The Chief pulled the nozzle toward himself, and after gaining control of the hose, he extinguished the fire near the apparatus. Using a fog spray, he then extinguished the fires on the three downed fire fighters. The remaining portion of the secondary fire burned itself out. At approximately 0718 hours, a power company technician arrived on scene with a utility truck and de-energized the line approximately 2 minutes later. At 0726 hours the Chief radioed Central Dispatch and requested two additional ambulances and a helicopter.

*Figure 3. Aerial View of Incident Site*
