Electrical Panel Explosion Claims the Life of a Career Assistant Fire Chief, an Electrician, and Seriously Injures an Assistant Building Engineer—Illinois

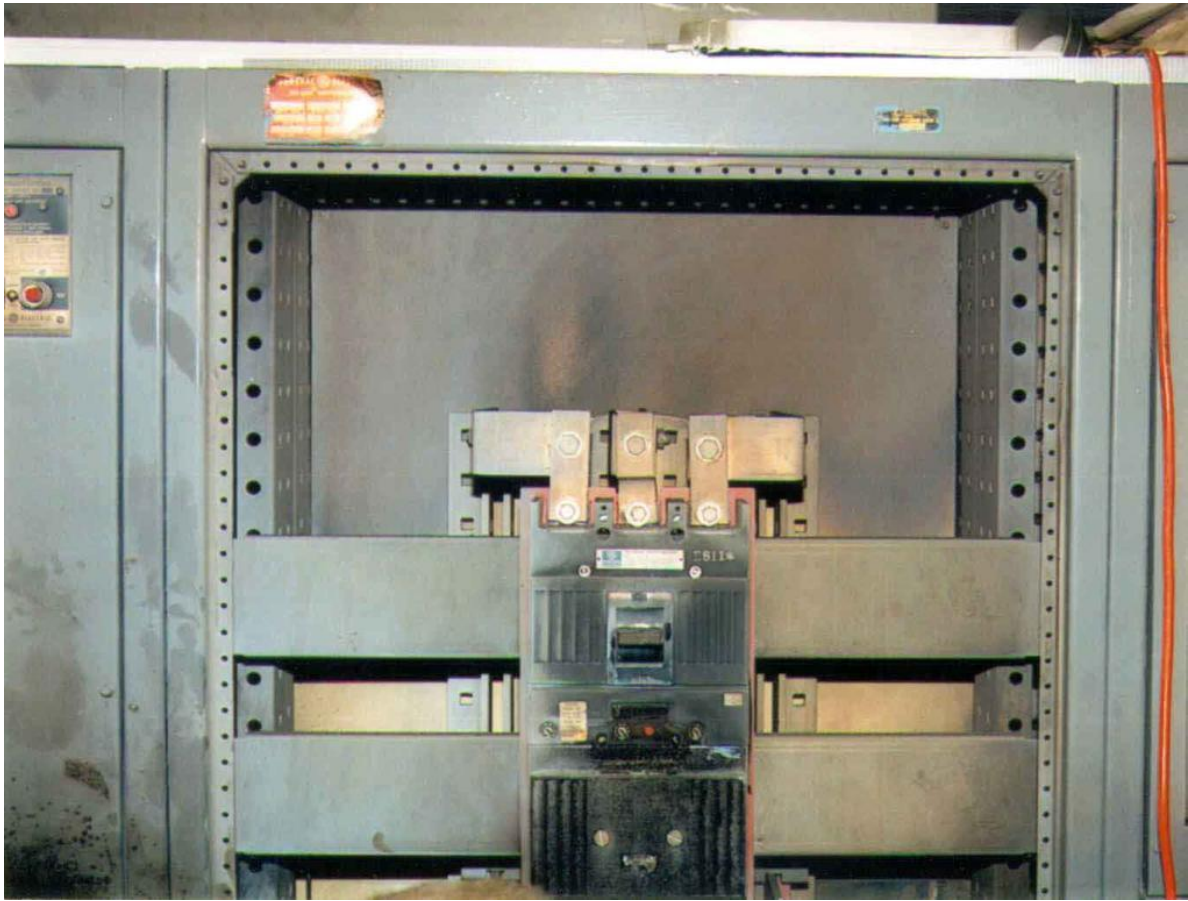
Photo 1. Emergency Power Breaker

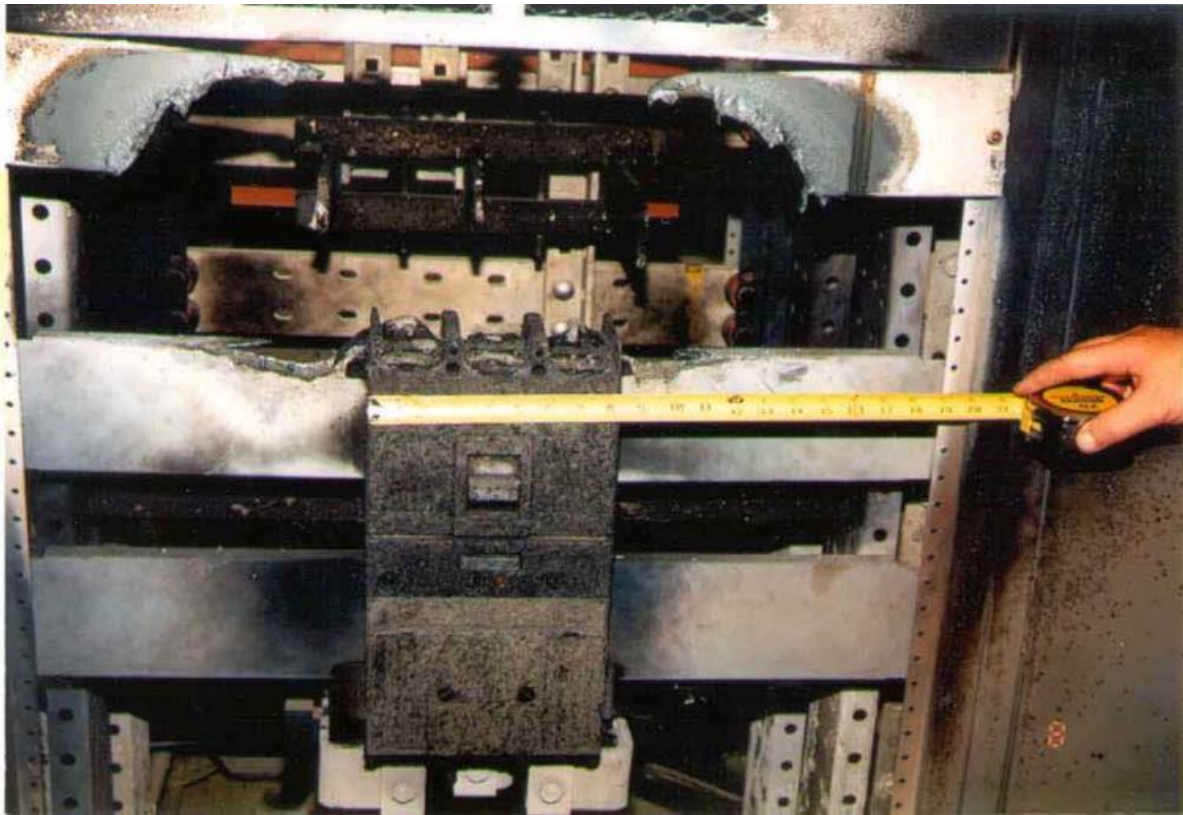
Photo 2. Vaporized Bus Bar
